investigation report

Report Name: Together Forged PM steels (sample 1)

Report Number: MUE 20015

Customer Supplier: Zapp Precision Metals

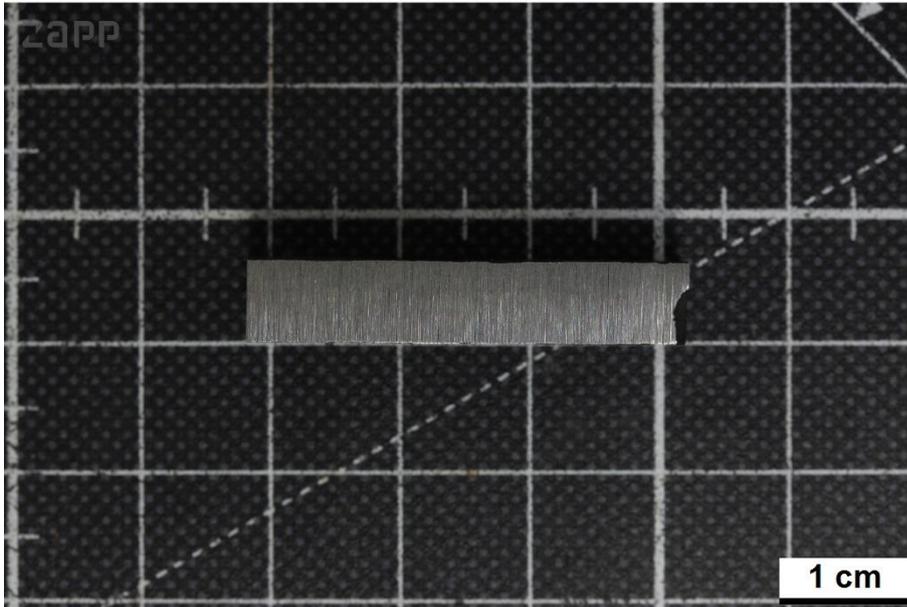
Illustration: 1

Pattern overview Sample 1

Summary and Conclusion: For an investigation forged pattern was filed, see Figures 1 and 2. At this pattern should examine each forged documents and hardness measurements are made at the individual layers. For the metallographic investigation of the material was prepared in the micrograph. In the center of the sample is a broad layer (seam), consisting of a PM steel with numerous carbides in a martensitic matrix, see Figure 3 and 7. In Figures 4 to 6, a transition zone, with ferritic appearance of the PM to recognize -Location to the base material. In Figures 5 and 6 partially flaws can be seen at the grain boundaries, which may be an etching effect are (dark areas). A closer examination of these areas is microscopically not feasible. In Figures 8 to 11 this transition zone appears dark. Figure 12 shows the martensitic microstructure of the base material. Next, as shown in Figures 13 and 14, a hardness profile measurement from the center of the PM-zone was seen, starting carried out to the edge. The following diagram shows the variation of hardness which falls off strongly towards the edge. The hardness value of the dark transition zone of 740 HV0.5 (s = +/- 20) is an average of three values.

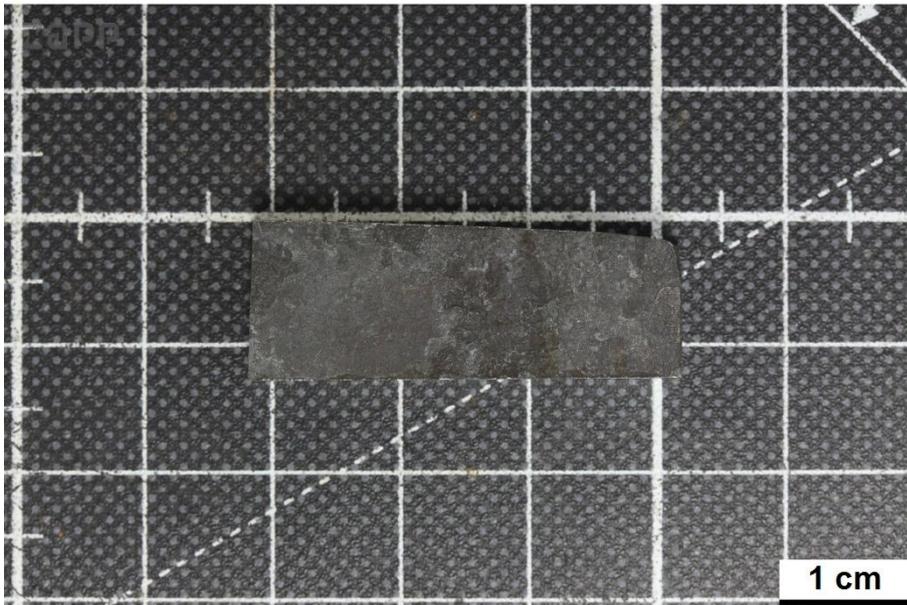
Illustration: 2

Pattern overview Sample 1

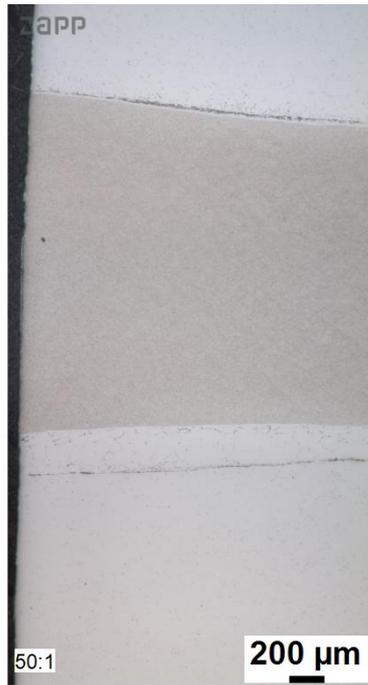
Illustration: 3
Etching: nital
Cut-No.: 6302
Sample Location: cross section

Overview

_PM zone in the middle

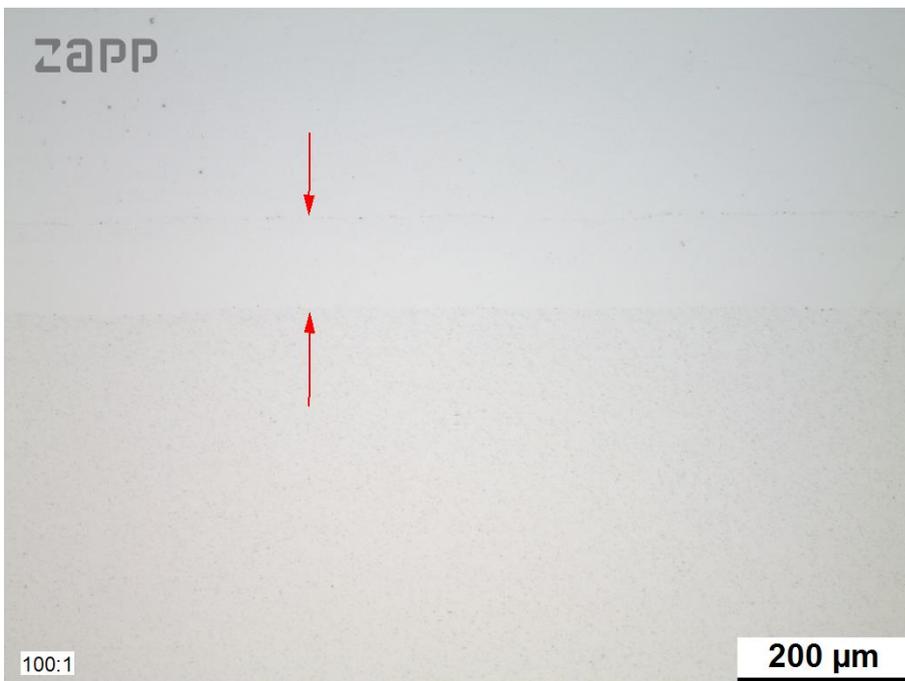
Illustration: 4
Etching: unetched
Cut-No.: 6302
Sample Location: cross section

Sample 1 - transition zone

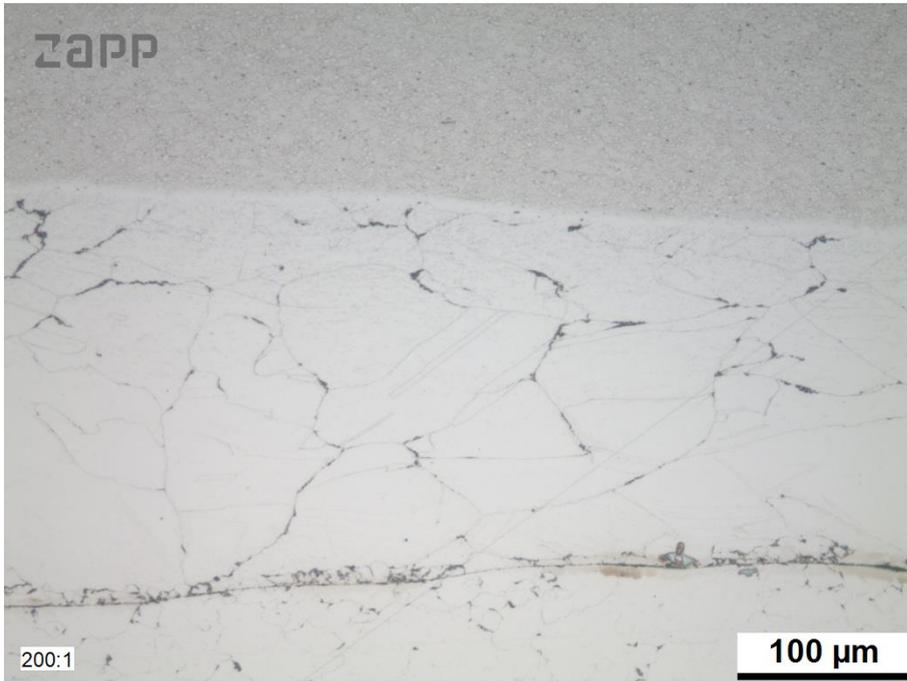
Illustration: 5
Etching: nital
Cut-No.: 6302
Sample Location: cross section

Transition zone

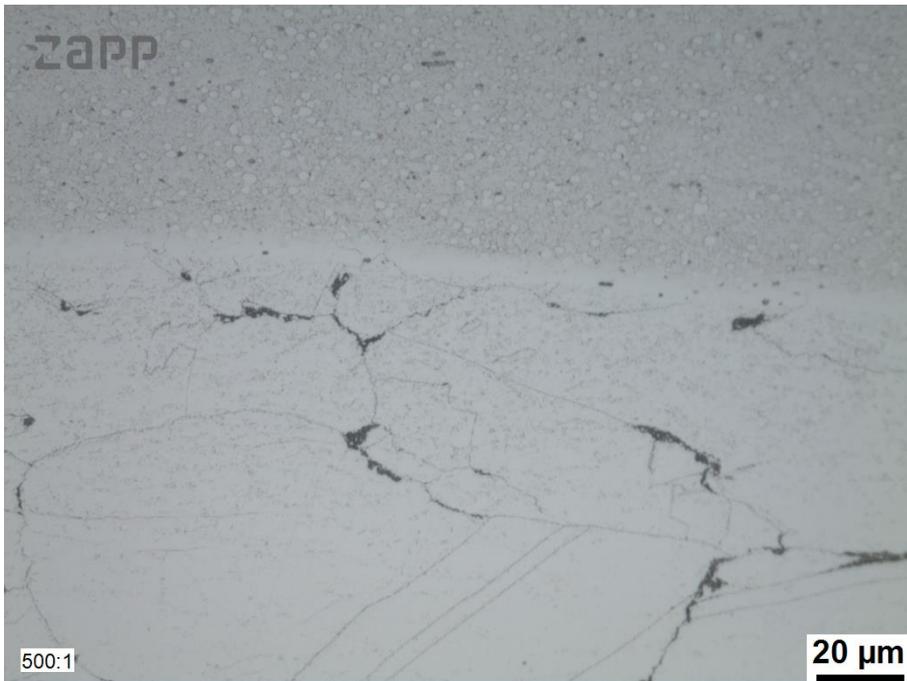
Illustration: 6
Etching: nital
Cut-No.: 6302
Sample Location: cross section

Transition zone

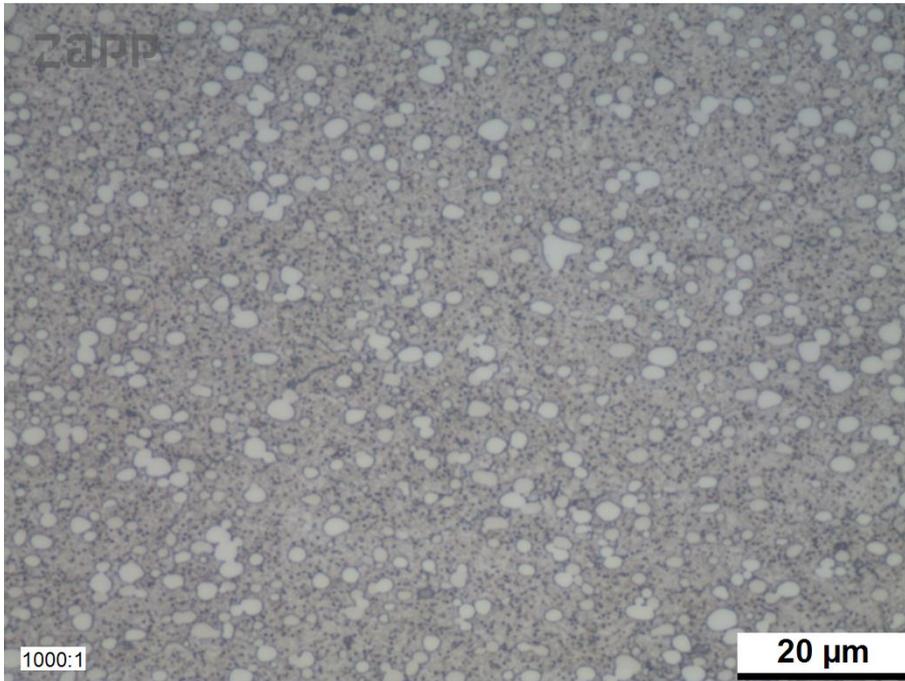
Illustration: 7
Etching: Recipe 104 (ASTM E407)
Cut-No.: 6302
Sample Location: cross section

PM-zone

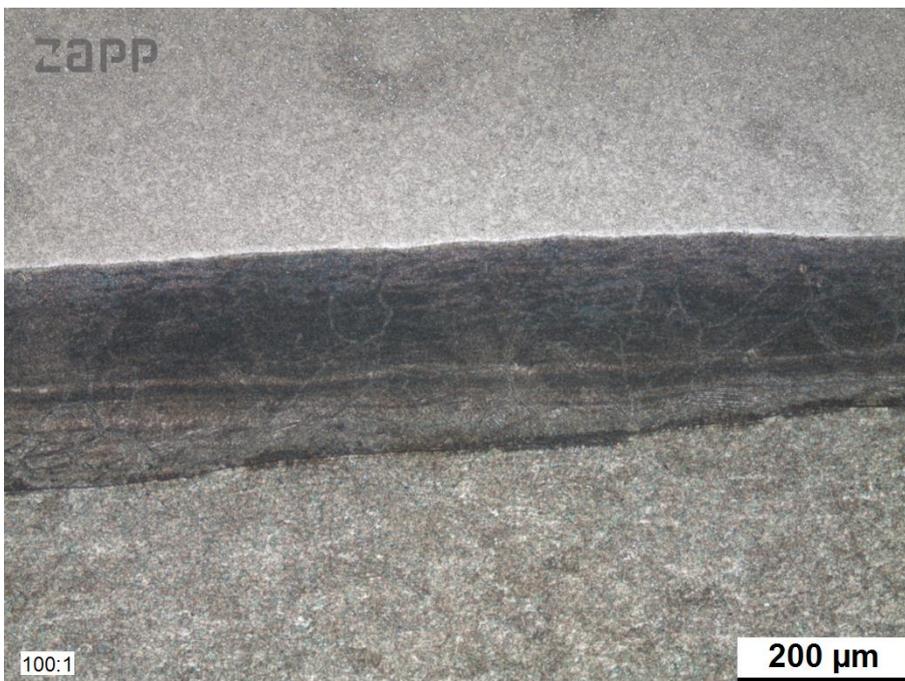
Illustration: 8h
Etching: Recipe 104 (ASTM E407)
Cut-No.: 6302
Sample Location: cross section

Transition area:

_from top to bottom: PM-zone -> Dark Zone -> basic matrix

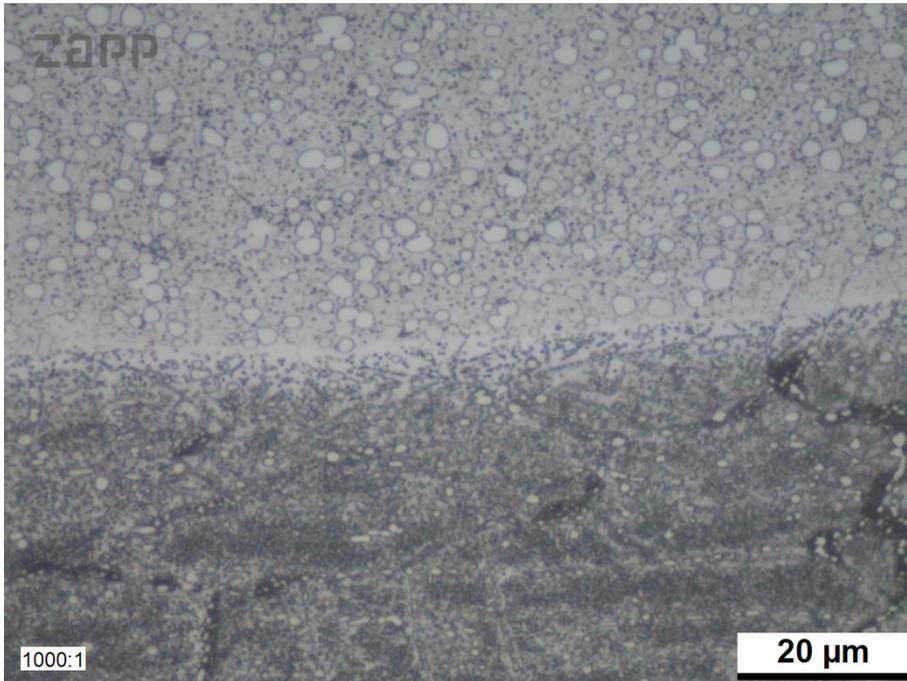
Illustration: 9
Etching: Recipe 104 (ASTM E407)
Cut-No.: 6302
Sample Location: cross section

PM transition zone to the dark zone

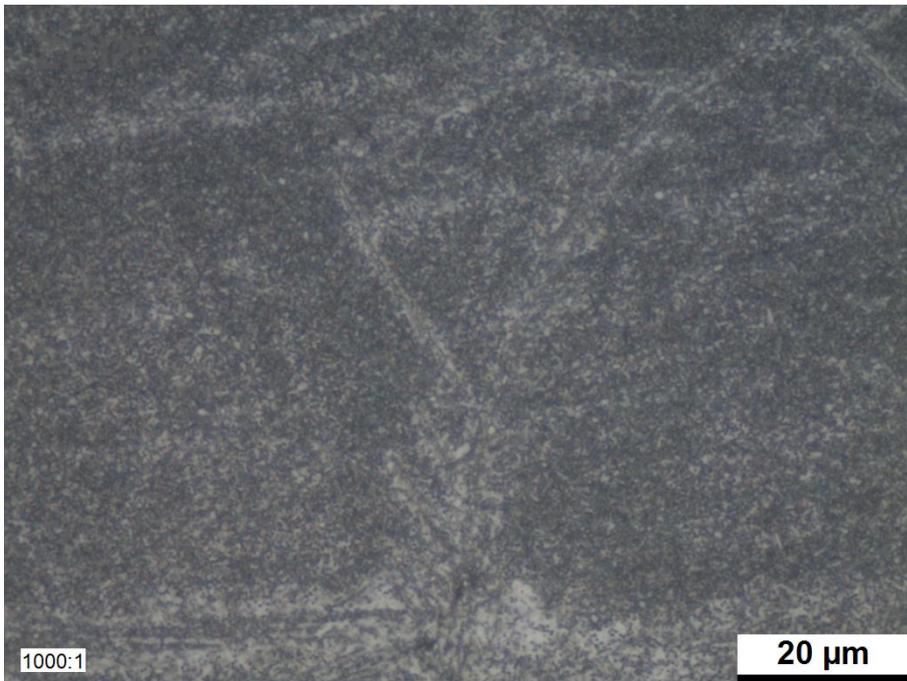
Illustration: 10
Etching: Recipe 104 (ASTM E407)
Cut-No.: 6302
Sample Location: cross section

dark transition zone

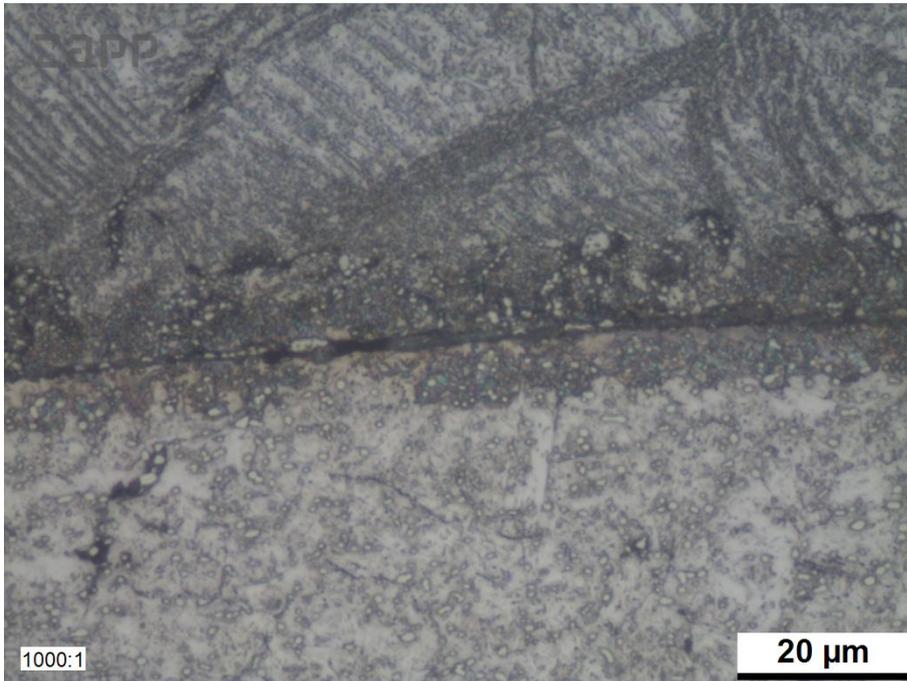
Illustration: 11
Etching: Recipe 104 (ASTM E407)
Cut-No.: 6302
Sample Location: cross section

Transition dark zone -> Basic Materials

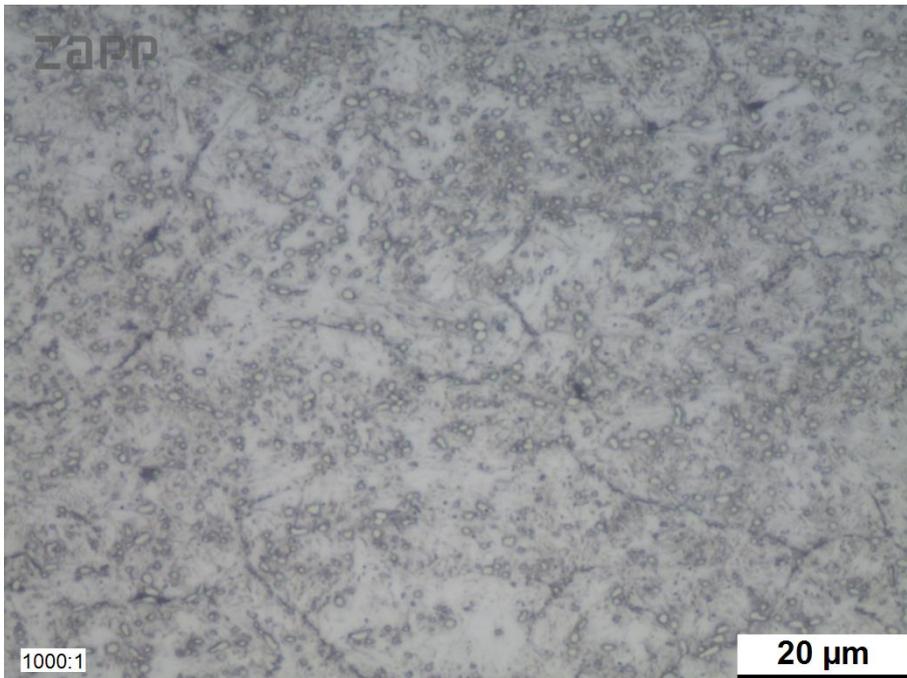
Illustration: 12
Etching: Recipe 104 (ASTM E407)
Cut-No.: 6302
Sample Location: cross section

Parent material

_martensitisches structure

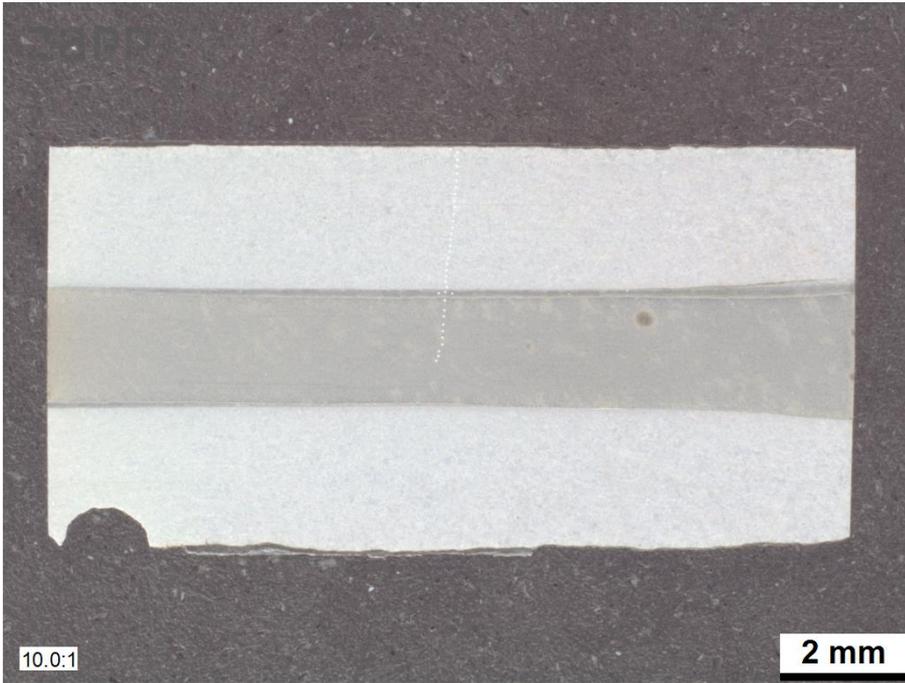
Illustration: 13
Etching: Recipe 104 (ASTM E407)
Cut-No.: 6302
Sample Location: cross section

Overview hardness profile

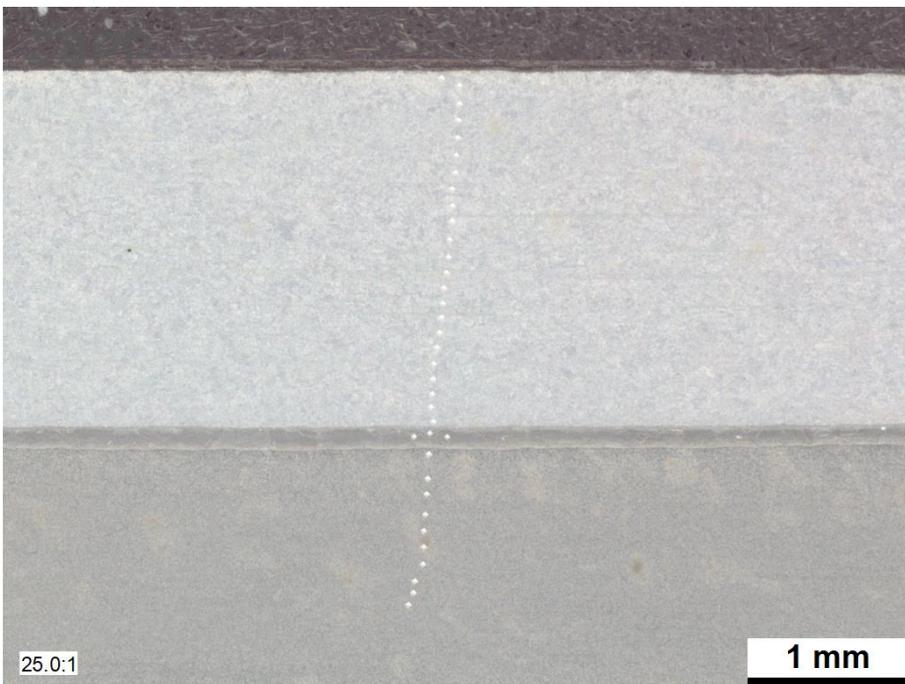
Illustration: 14
Etching: Recipe 104 (ASTM E407)
Cut-No.: 6302
Sample Location: cross section

Overview hardness profile
